**SAS Superstructure**

Daily Diary Report by Bid Item

Contract No.: 04-0120F4

**04-0120F4
04-SF-80-13.2/13.9
Self-Anchored
Suspension Bridge****Weather****Temperature** 7 AM 50 - 60 12 PM 50 - 60 4PM 50 - 60**Precipitation** 0.40"**Condition** Mostly rain with overcast skiesWorking Day ☐ If no, explain:**Diary:**

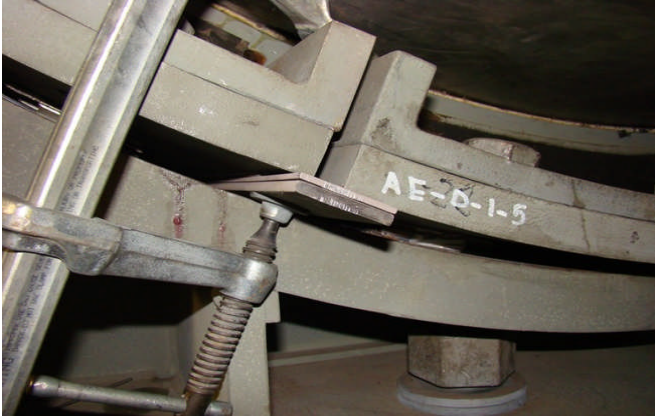
Filler shim seen in the Skyway at Diaphragm D looking west for grouting the annulus between the bearing shoes and circular sleeve plate.

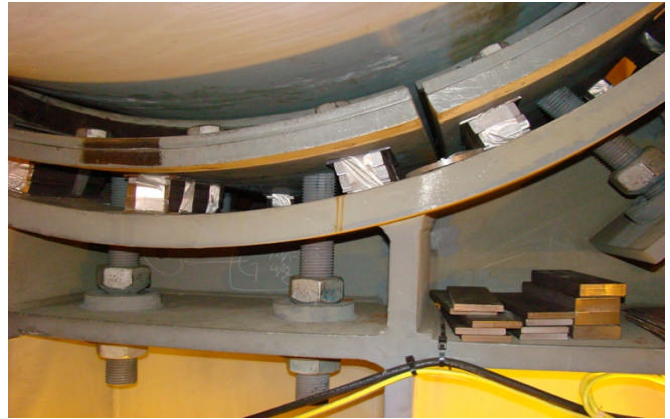
Composite lead and steel shims seen in the SAS North Diaphragm B looking west.

- ABF ironworkers began their shift at 8:00pm Friday November 16th and worked 12hrs until 8:30am Friday morning November 17th. See Parviz Jalali and Bob's diaries for the installation/gap measurements for the Lead + Steel shims, labor, and equipment. The majority of the shift consisted of shim placement in the E-Line SAS. No measurements were taken on the Hinge A pipe beams tonight as there was no adjustments made. I am on call to perform any measurements when the time comes however I will be working on other issues such as the one below in the downtime. See Bob Brignano's diaries on Saturday and Sunday regarding the North W-Line Hinge A pipe beam alignment operations and QA check.
